Kristianstad Heliga Trefaldighets kyrka

Documentation of the 1631 Lorentz-organ

RÜCKPOSITIV CASE
- situation 2018: sections, top view
- reconstruction back

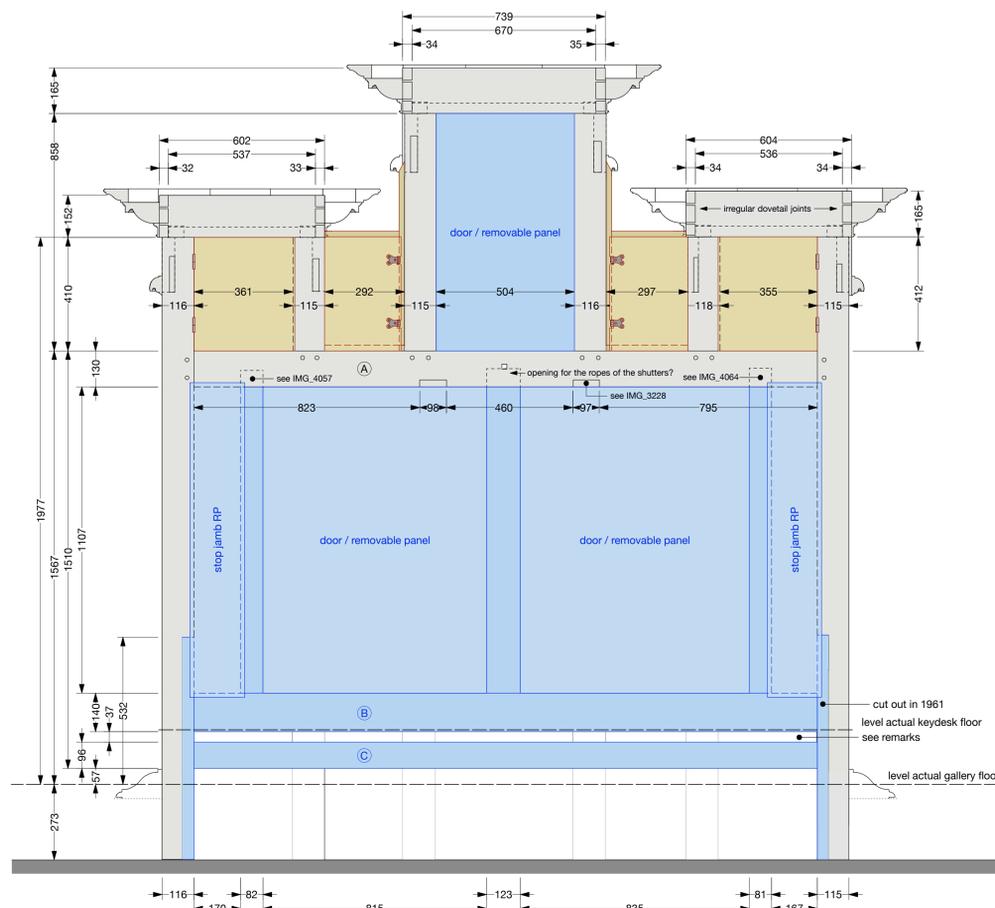
Reconstruction back

- The traces in rail A have no counterpart in any other preserved part of the case. Therefore it is less probable that they were part of pipe-racks for long flue pipes or reed resonators.

- The distance between the two mortises does not necessarily imply that there was a corresponding opening between the rails B and C. However, if this was actually the case, it could have served as a passage for the key-action to a vertical pallet-box. The depth of the RP case is sufficient for a windchest with the known specification and such a pallet-box. In that case the keydesk floor level must have been about 5 cm higher than the actual one.

- The parts that now serve as roof for the towers seem to be old doors or removable panels. However, they do not fit in any way into a plausible reconstruction of the back of the RP case. The rather atypical profiles do not match any other profiles preserved in the case now. It is not to be excluded that they originate from another organ or piece of furniture.
